# AEROMEDICAL REVIEW

## ULTRASONIC CLEANERS

March 1982

USAF SCHOOL OF AEROSPACE MEDICINE  
Aerospace Medical Division (AFSC)  
Brooks Air Force Base, Texas 78235

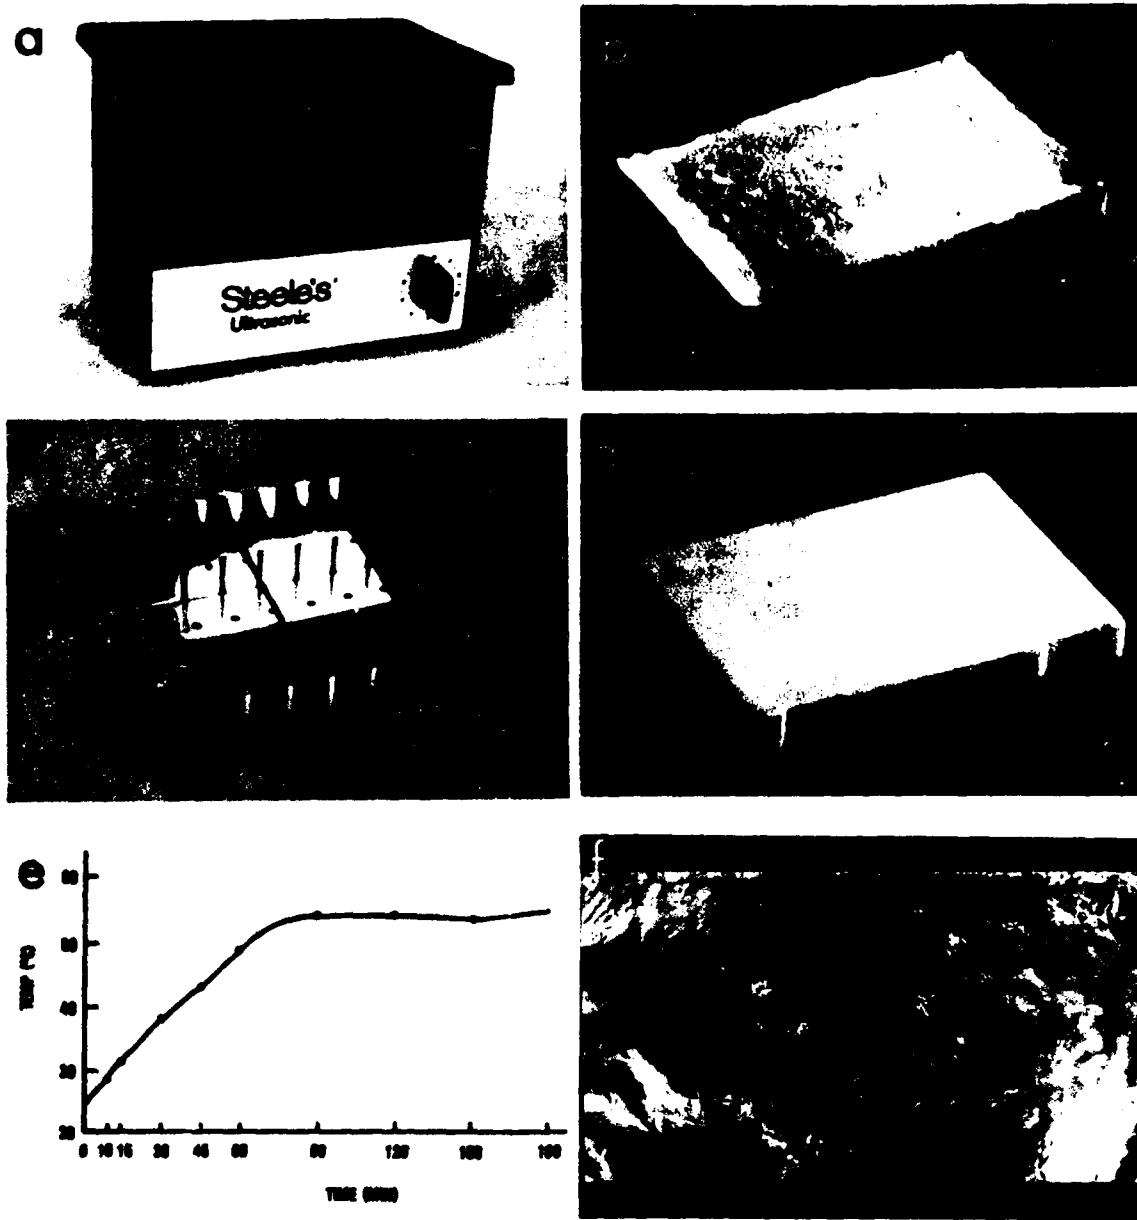
Figure 2. Steele's SS-4 ultrasonic unit:

- a - Ultrasonic cleaner with basket and lid in place.
- b - Superior surface of type IV stone slab placed in cleaner 5 min.
- c - Basket.
- d - Inferior surface of stone slab showing effect of sonication through basket.
- e - Temperature elevation during 3 hr of continued use.
- f - Erosion of aluminum foil after 4 min of sonication.

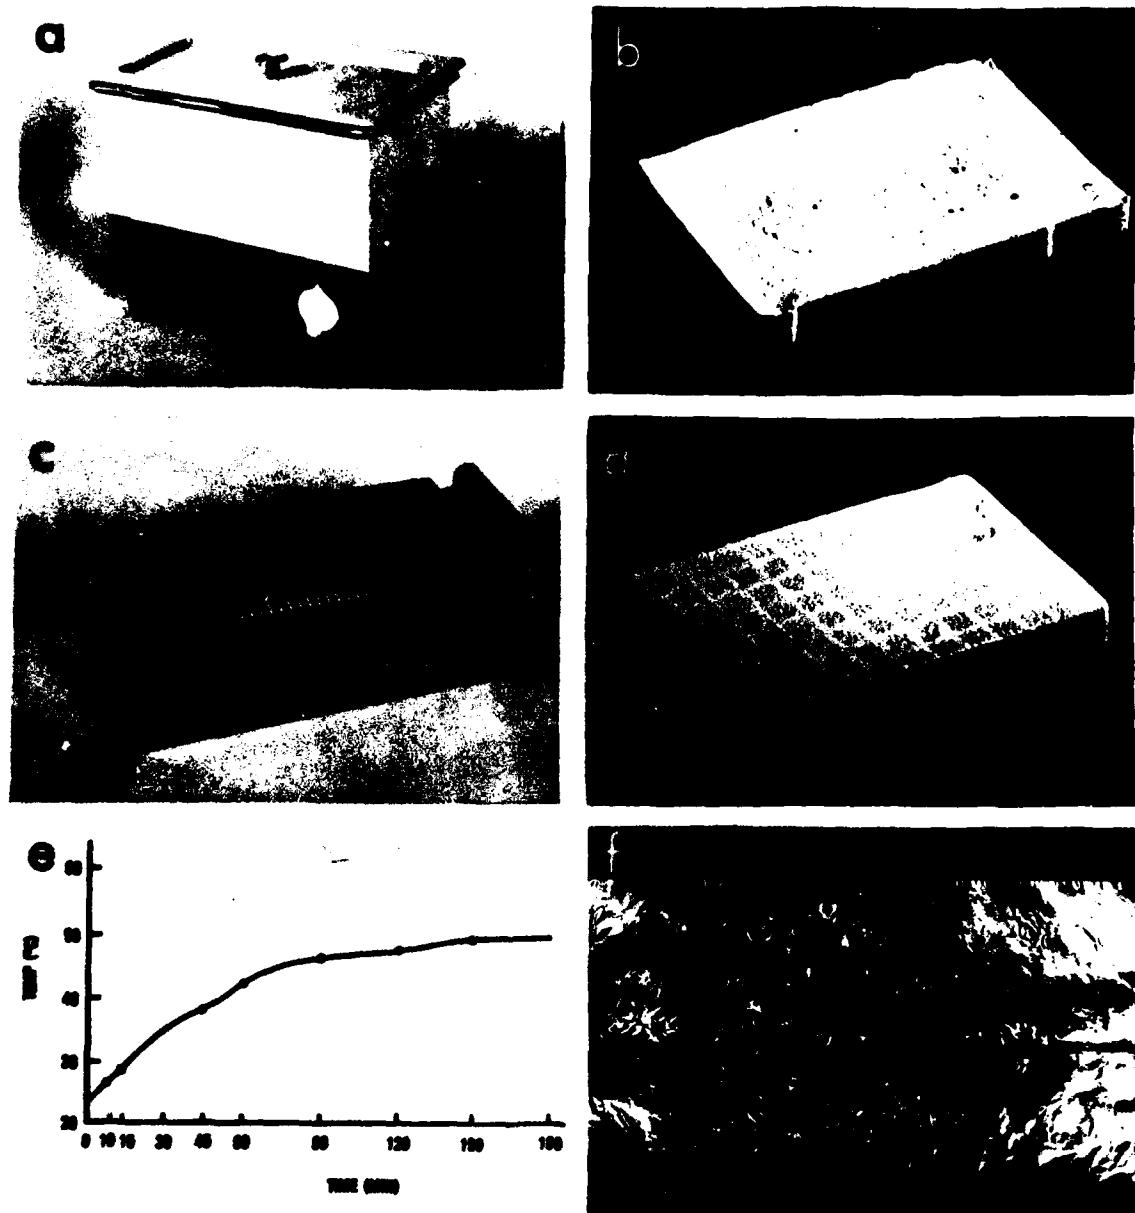
Figure 3. Health Aids T3.3B ultrasonic unit:

- a - Ultrasonic cleaner with basket and lid in place.
- b - Superior surface of type IV stone slab placed in cleaner 5 min.
- c - Basket.
- d - Inferior surface of stone slab showing effect of sonication through basket.
- e - Temperature elevation during 3 hr of continued use.
- f - Erosion of aluminum foil after 4 min of sonication.

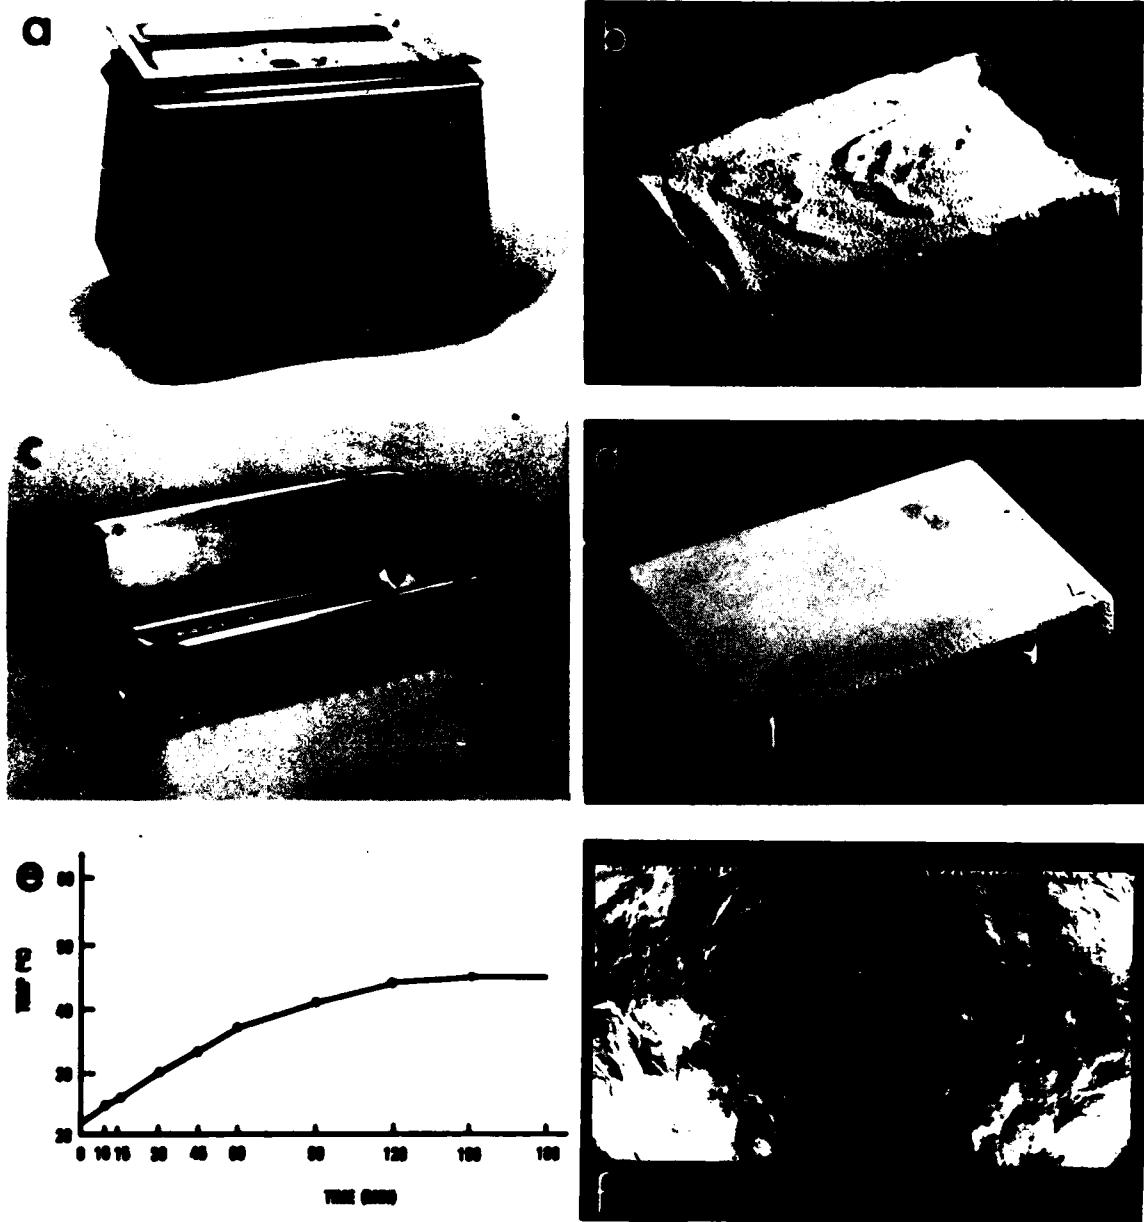
Figure 4. Vector 55 ultrasonic unit:

- a - Ultrasonic cleaner with basket and lid in place.
- b - Superior surface of type IV stone slab placed in cleaner 5 min.
- c - Basket.
- d - Inferior surface of stone slab showing effect of sonication through basket.
- e - Temperature elevation during 3 hr of continued use.
- f - Erosion of aluminum foil after 4 min of sonication.

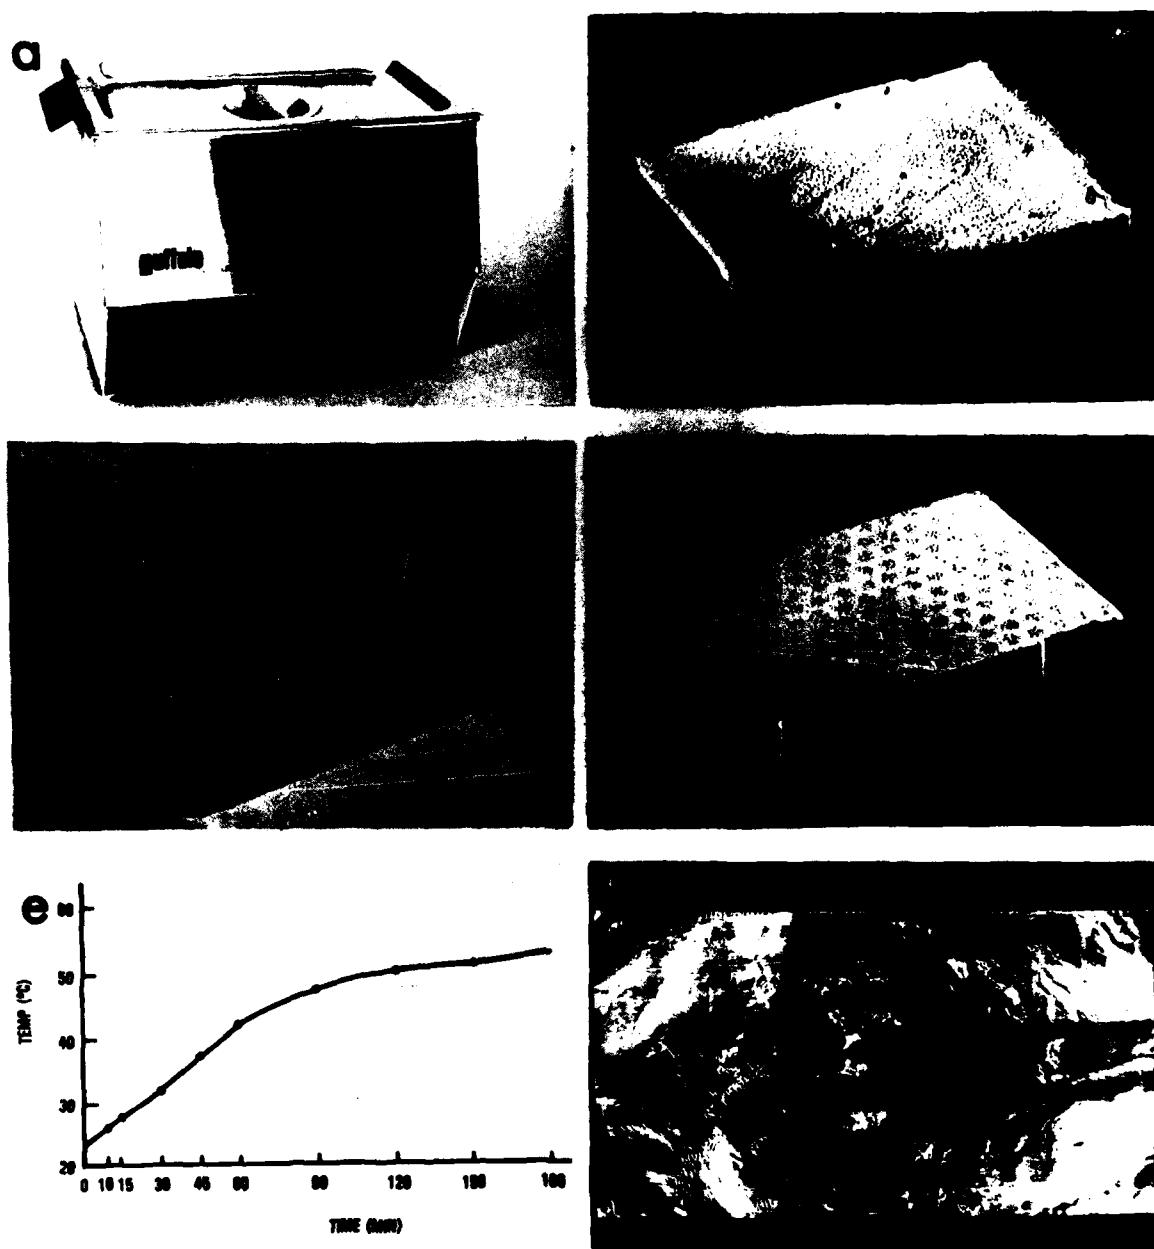
Figure 5. Buffalo 773 ultrasonic unit:  
 a - Ultrasonic cleaner with basket and lid in place.  
 b - Superior surface of type IV stone slab placed in cleaner 5 min.  
 c - Basket.  
 d - Inferior surface of stone slab showing effect of sonication through basket.  
 e - Temperature elevation during 3 hr of continued use.  
 f - Erosion of aluminum foil after 4 min of sonication.

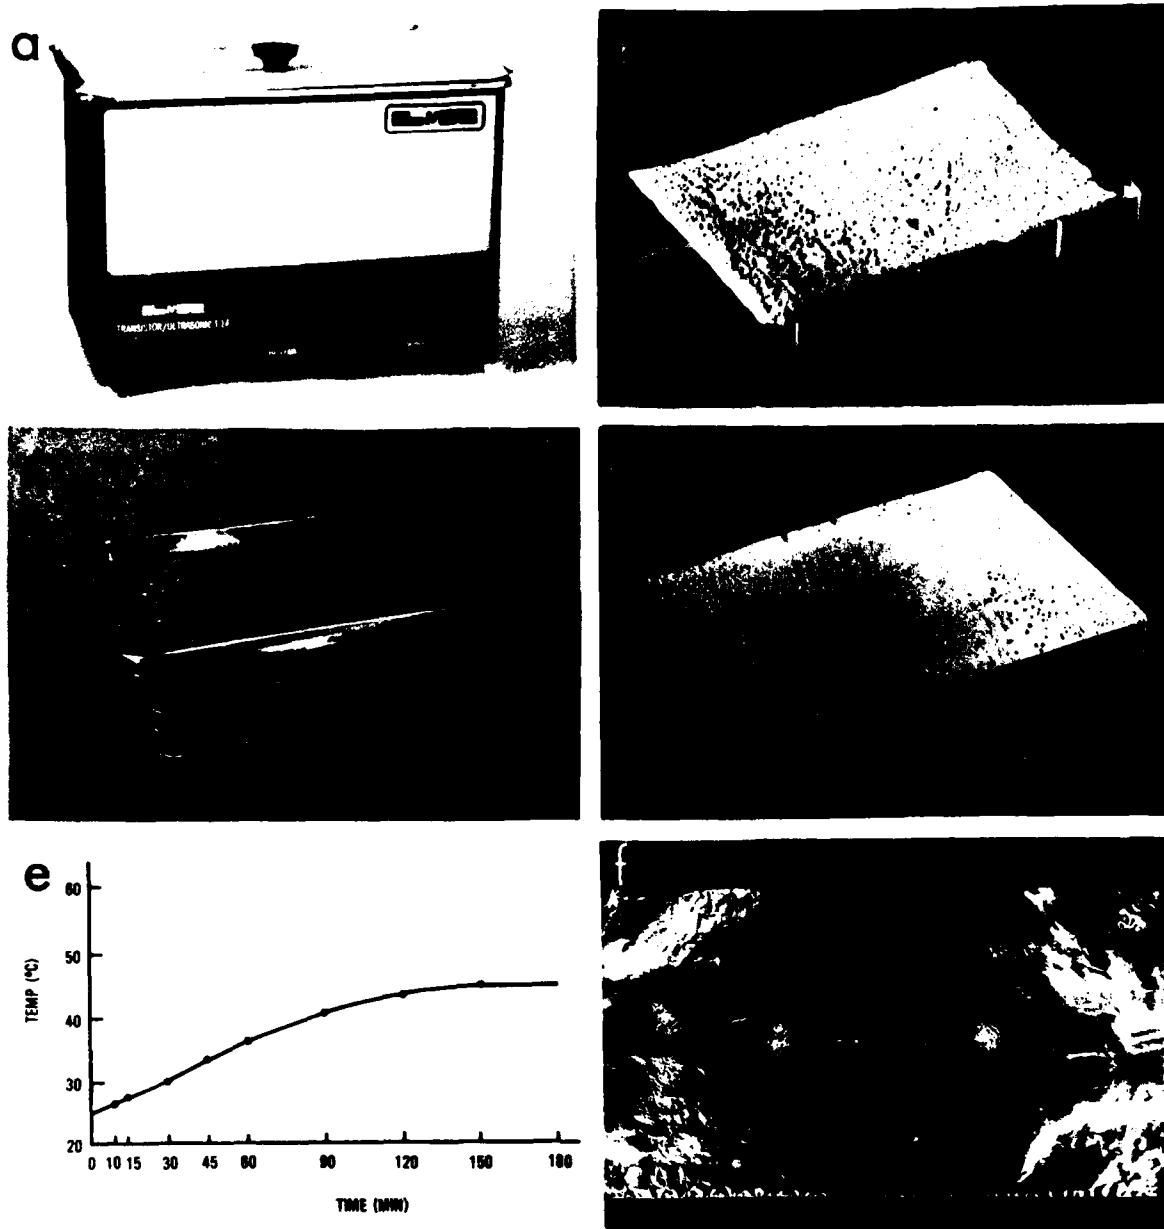
Figure 6. L&R T-14 ultrasonic unit:

- a - Ultrasonic cleaner with basket and lid in place.
- b - Superior surface of type IV stone slab placed in cleaner 5 min.
- c - Basket.
- d - Inferior surface of stone slab showing effect of sonication through basket.
- e - Temperature elevation during 3 hr of continued use.
- f - Erosion of aluminum foil after 4 min of sonication.

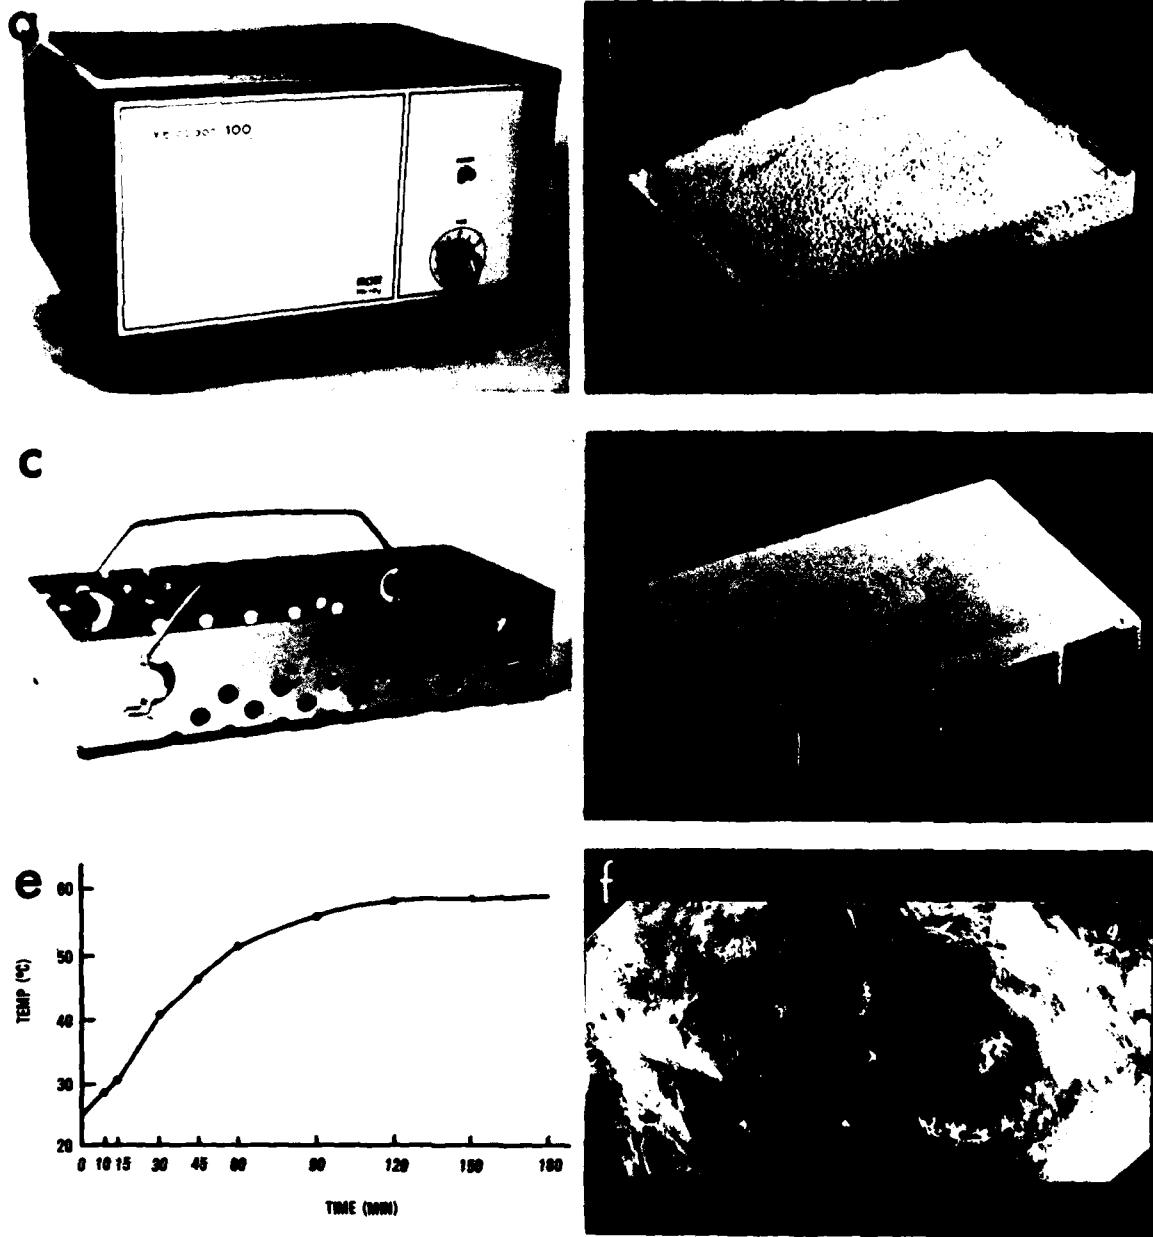
Figure 7. Vibraclean 100 ultrasonic unit:

- a - Ultrasonic cleaner with basket and lid in place.
- b - Superior surface of type IV stone slab placed in cleaner 5 min.
- c - Basket.
- d - Inferior surface of stone slab showing effect of sonication through basket.
- e - Temperature elevation during 3 hr of continued use.
- f - Erosion of aluminum foil after 4 min of sonication.

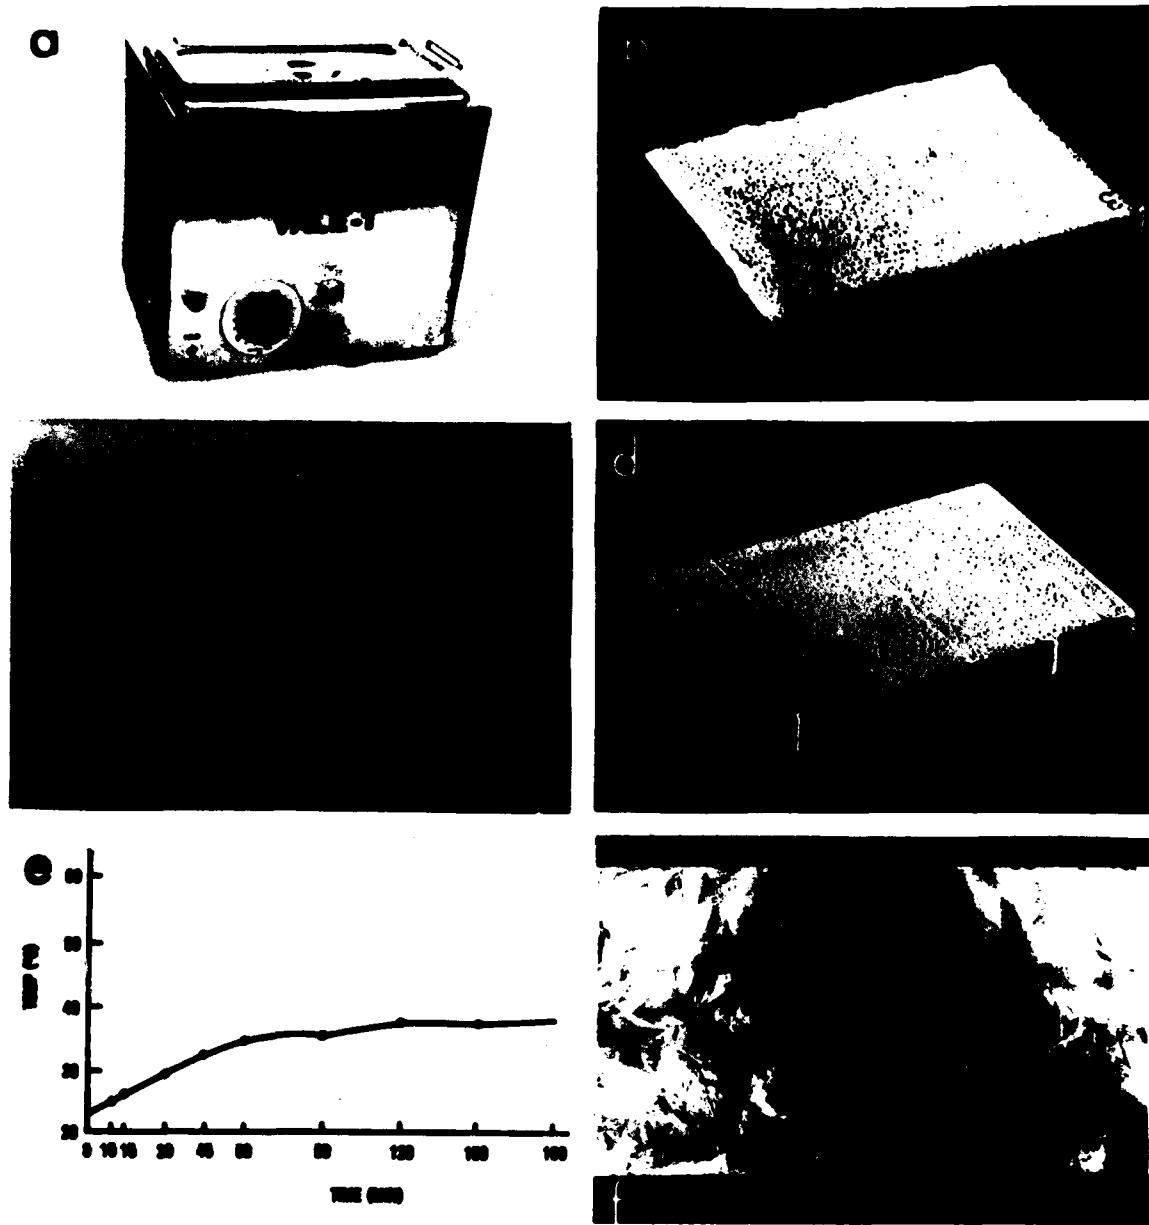
Figure 8. Vale-1 ultrasonic unit:

- a - Ultrasonic cleaner with basket and lid in place.
- b - Superior surface of type IV stone slab placed in cleaner 5 min.
- c - Basket.
- d - Inferior surface of stone slab showing effect of sonication through basket.
- e - Temperature elevation during 3 hr of continued use.
- f - Erosion of aluminum foil after 4 min of sonication.
